# CITY OF REDMOND FACILITIES STRATEGIC MANAGEMENT PLAN

# RESOURCES

PRE-FINAL DRAFT

Prepared by:  
MAKERS architecture and urban design LLP

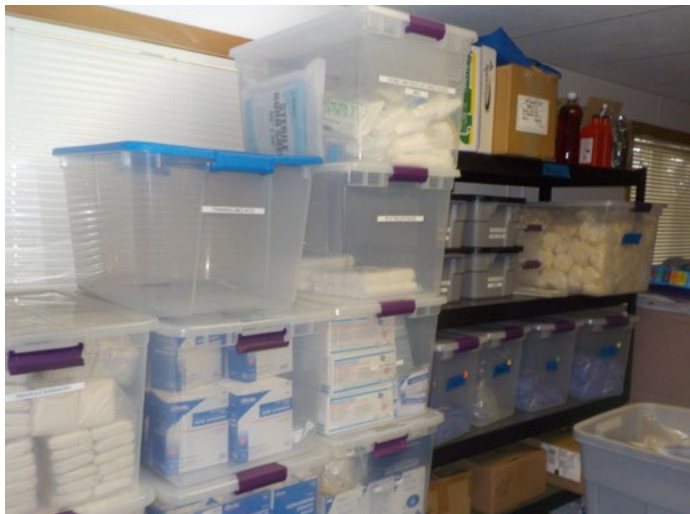
IMAGE 2. Overflowing Storage At Old Medic One

**CONDITION OF FINISHES**  
**CONSTRUCTION QUALITY**  
**INADEQUATE SIZE OF STORAGE SPACES**  
**INADEQUATE SIZE OF MEETING SPACES**

The building is undersized and inadequate for storage and meeting purposes and interior finishes are worn. The 2016 Occupant Survey found occupants (presumably Fire staff who occasionally use the building) are dissatisfied with almost all aspects of this facility.

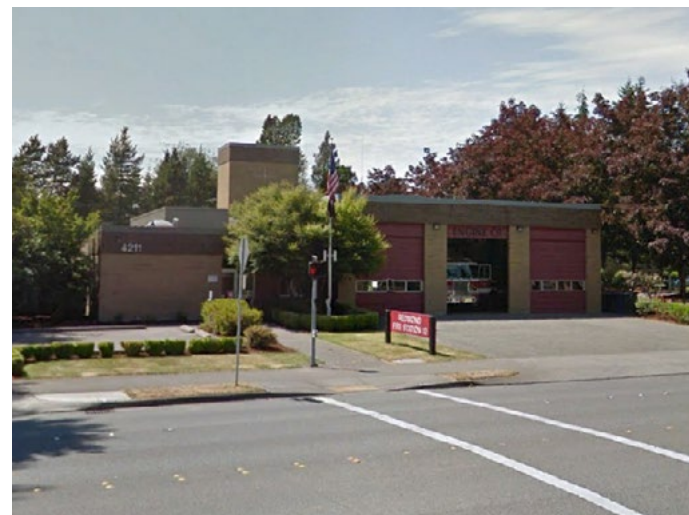
IMAGE 3. Fire Station 12

Major issues include lack of roof insulation and inadequate electrical outlets in the apparatus bay. HVAC and plumbing could also be upgraded to better the needs of this facility. However, the 2016 Occupant Survey found occupants are highly satisfied with this facility. The most significant occupant issue of note is the size and configuration of meeting areas.

#### ELECTRICAL SYSTEMS IN APPARATUS BAY

#### SIZE OF WORK AND MEETING SPACES

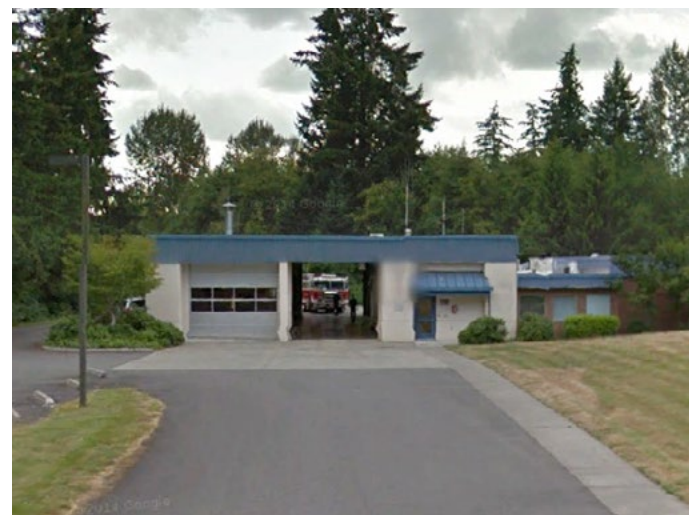
IMAGE 4. Fire Station 13

Being the oldest fire station, the facility's HVAC, electrical, and plumbing systems are nearing end of life and need to be upgraded to improve efficiency and comfort. There is also insufficient seismic bracing between walls and the roof. However, the 2016 Occupant Survey found occupants are generally satisfied with this facility. Issues of note are thermal comfort, meeting areas, size and configuration of storage spaces, and availability of commute transportation options.

#### AT END OF LIFE

#### CARPET FLOORING

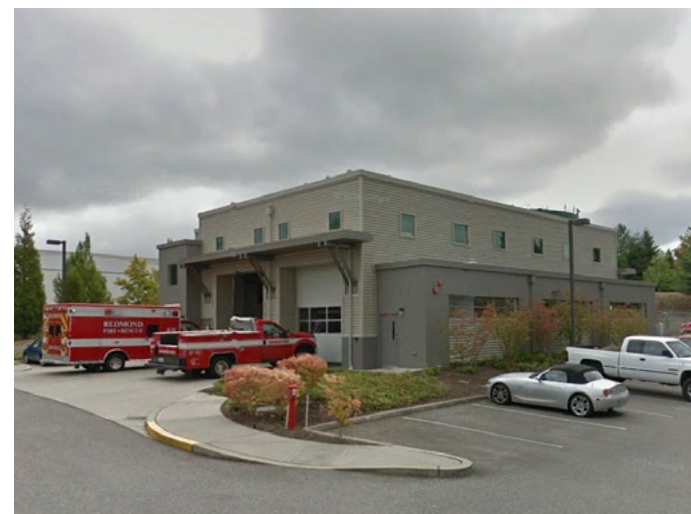
IMAGE 7. Fire Station 16 Shop Front Driveway

**CODE VIOLATION WITH NO ROOF INSULATION**  
**INADEQUATE ELECTRICAL SYSTEMS IN SHOP BAY**

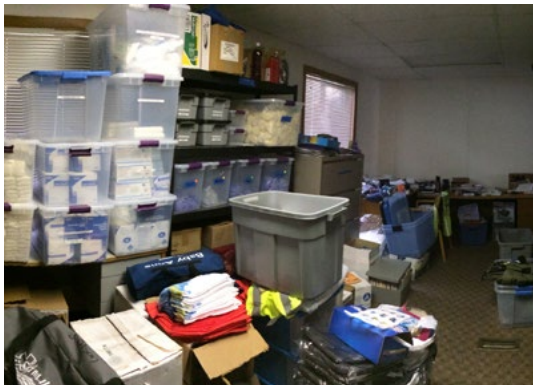
IMAGE 13. Overflowing Storage at Old Medic One

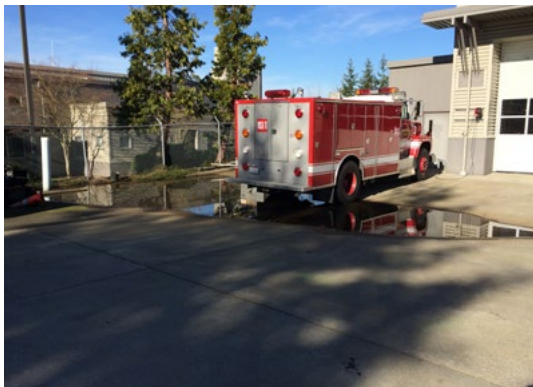
IMAGE 15. Ponding at Testing Area Outside FS 16 Shop

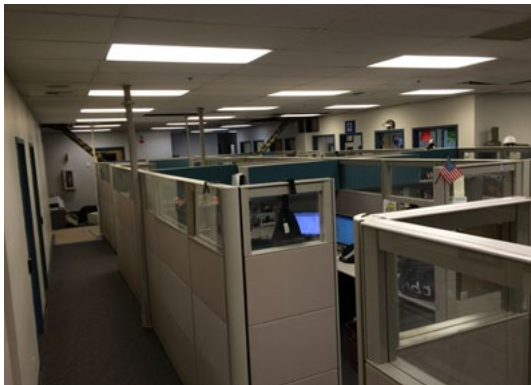
IMAGE 20. Oversized Cubicles

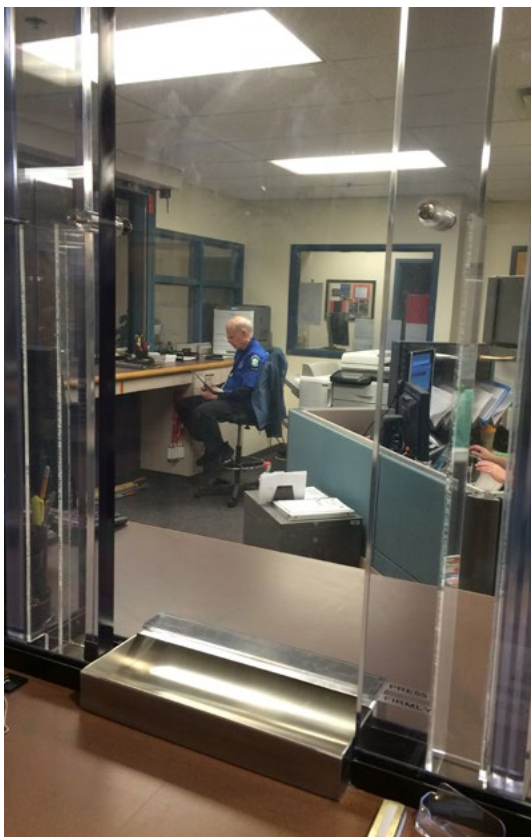
IMAGE 21. Plexiglas Configuration at Customer Service Desk Impedes Communication

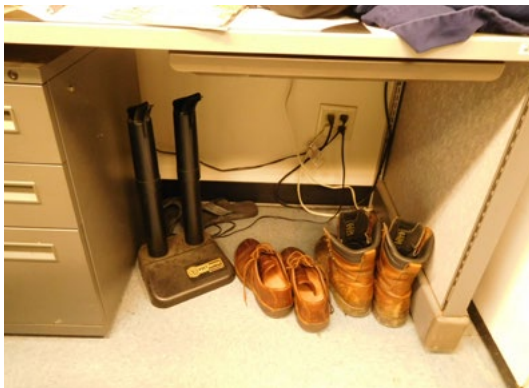
IMAGE 58. Boot Drying in Crew Office Space

- Conference, training, and EOC spaces are inadequate.
- Decontamination and drying facilities are undersized (Parks) or absent (Public Works).
- Outdoor fleet and staff parking is at, or will soon exceed, capacity.

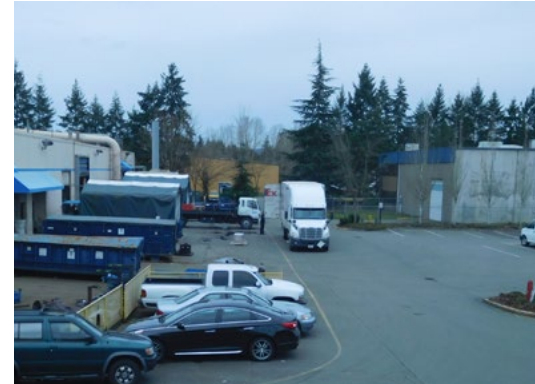
Site circulation is loosely defined and highly constrained in some areas. The lack of clearly defined and separated pedestrian routes in conjunction with heavy vehicle traffic poses a potential safety risk. The neighboring business, Genie Industries, shares the eastern-most site access and narrow drive aisle with the City of Redmond, but they also use areas of the City's site to turn vehicles around. Though Park Operations work is concentrated on the east end of the site, their trucks also use the main Public Works access gate due to on-site congestion.

IMAGE 60. Constrained Eastern-most Entrance Shared With Genie

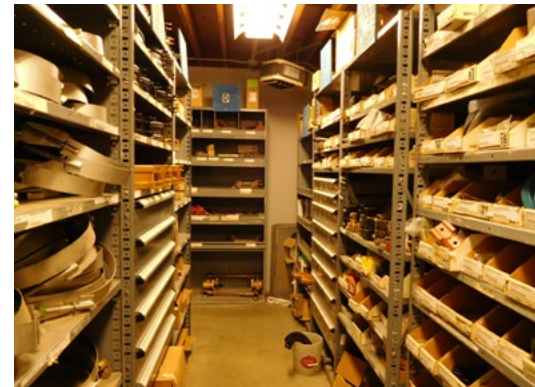
Public Works' current methods for procuring and storing equipment and supplies are inefficient and ineffective. Storage on site is generally dispersed and not clearly organized. Tools and materials are checked out directly by staff using a clipboard, limiting inventory management and control. Parts and supplies for small engine maintenance are stored separately from the small engine repair shop. There is also an identified need for consumables storage at the Municipal Campus, including custodial and maintenance supplies for City Hall. These supplies are currently stored at the MOC. The consolidation of storage functions at a centralized facility is a priority issue. Landscaping materials now stored in open bins are also better stored under cover.

IMAGE 61. Central Stores Warehouse at Capacity on 1st Floor

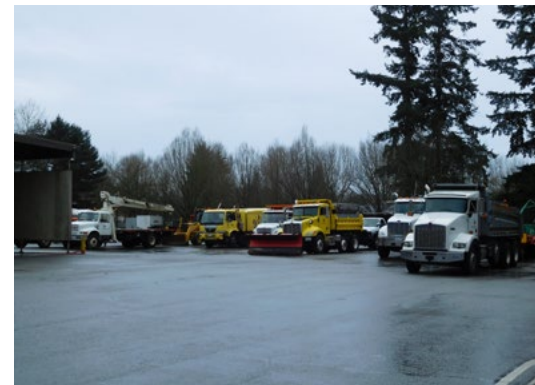
Vehicles parked outdoors incur increased maintenance costs and reduce operational efficiency as crews must winterize vehicles daily. Public Works vactor and CCTV trucks risk expensive freezing damage because they lack heated, covered parking. Water meter readers reduce time spent entering and exiting their vehicles by removing the doors from their vehicles, thereby increasing their efficiency. However, due to a lack of covered parking, they are currently required to reinstall the doors at the end of each day. The City is interested in adding electric vehicles to their fleet, but the MOC does not have the electrical service to support EV charging.

IMAGE 62. Fleet Vehicles Parked Outside Are Exposed to Weather

- Additional covered and heated fleet parking is needed; this may be addressed by the Trinity Building project.
- There is a 2011 Fleets study recommendation to combine Public Works Fleet Maintenance and Fire Fleet Maintenance.

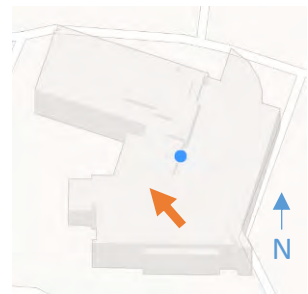
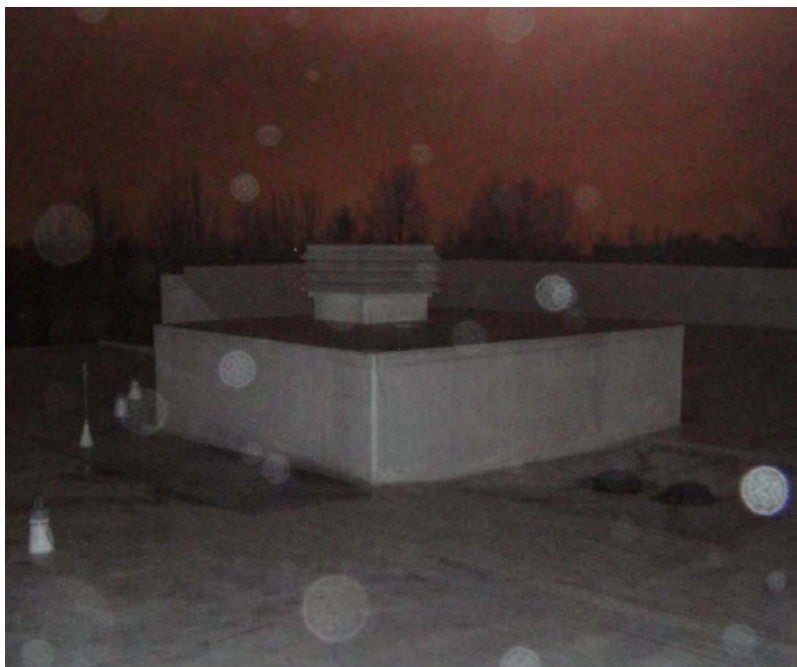
4<sup>th</sup> Floor Roof, Fright Elevator Shaft,  
Southeast corner of cap.

Thermal bridging though the walls of the elevator shaft.

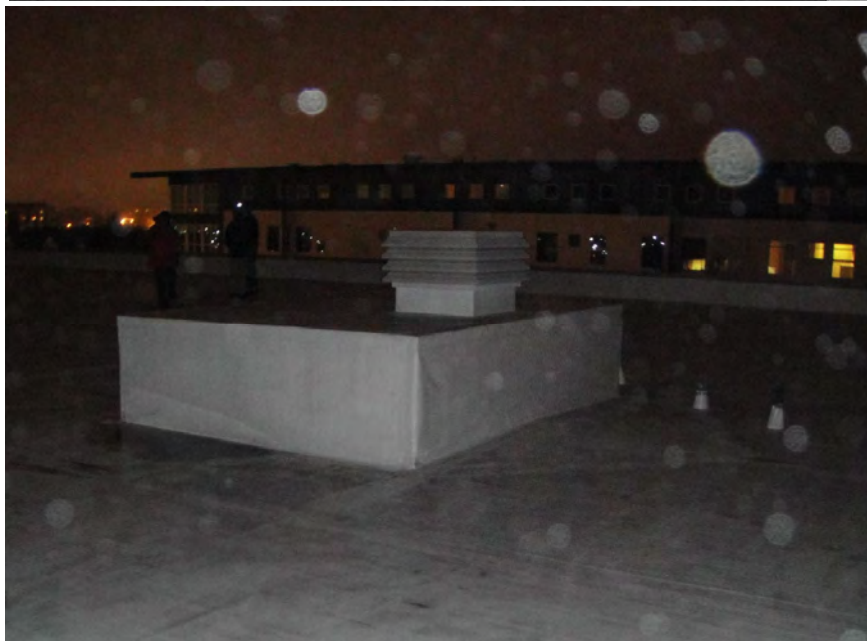
## 4<sup>th</sup> Floor Roof, Fright Elevator Shaft, Northwest corner of cap.

Thermal bridging through the walls of the elevator shaft.

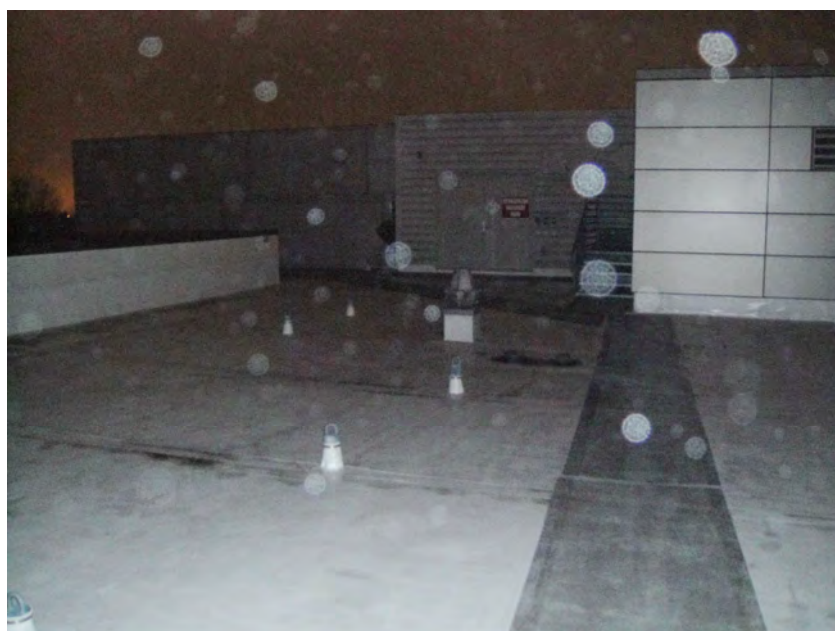
4<sup>th</sup> Floor rooftop, and door entryway.

Heat escaping around the edge of the door frame for the mechanical room.

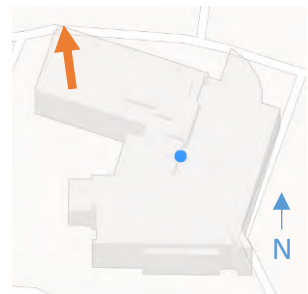
4<sup>th</sup> Floor Roof level, Northwest corner architectural wing.

Thermal bridging at intersection of roof and wing wall

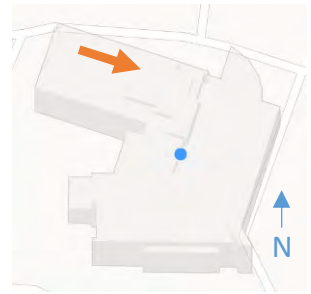
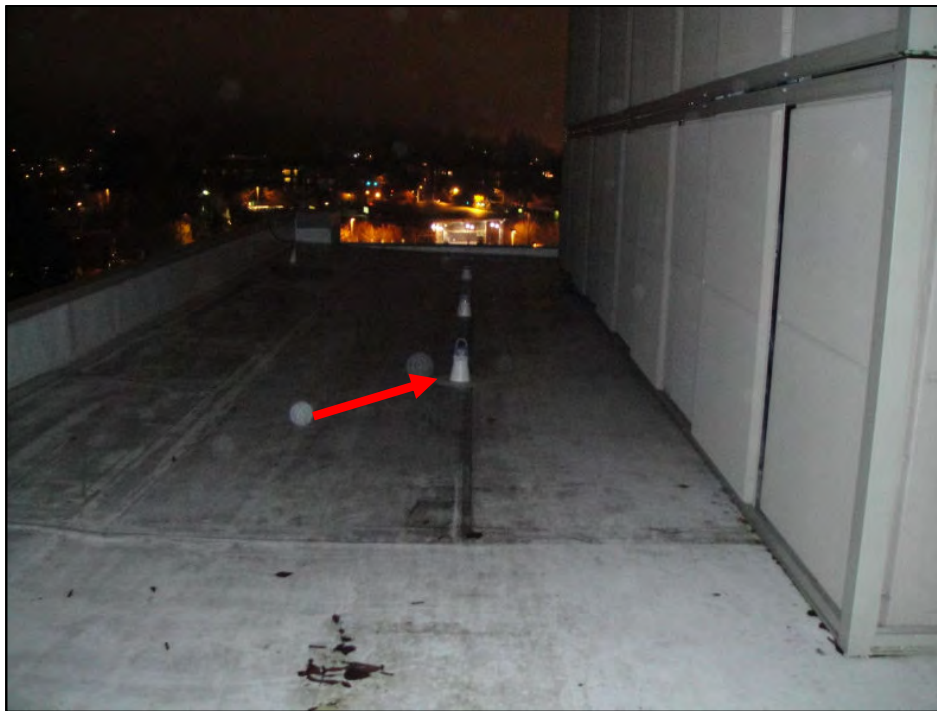
4<sup>th</sup> Floor Roof, Northeast corner.

Thermal bridging from fall protection footings.

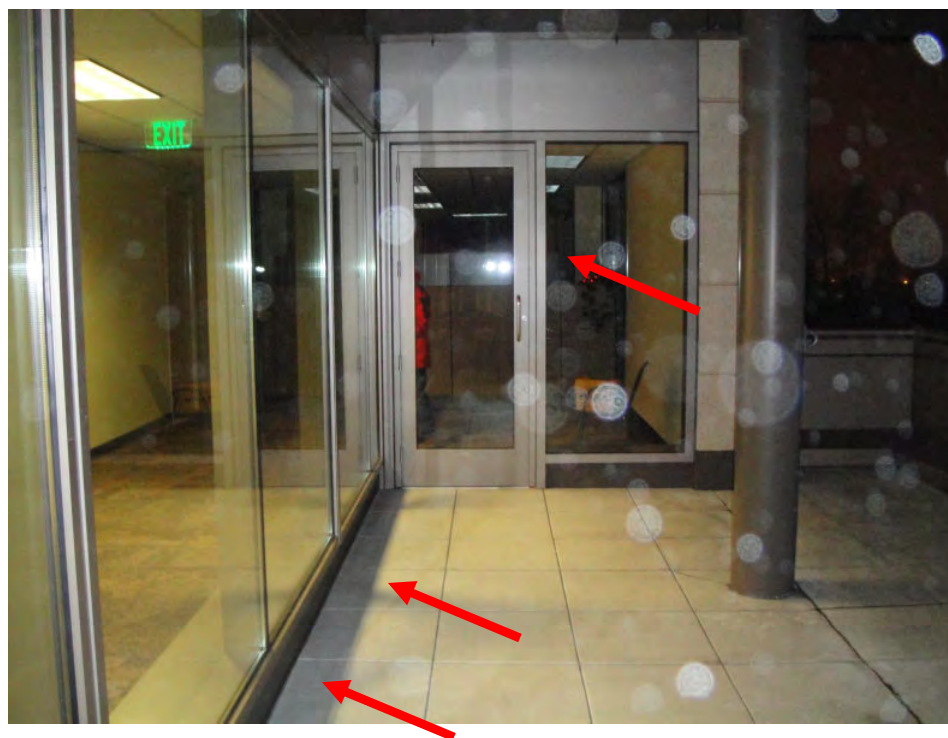
## 4<sup>th</sup> Floor, North Balcony

Heat escape from the West door frame and base of south wall

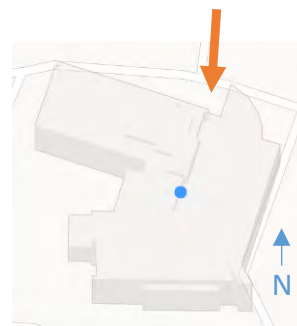
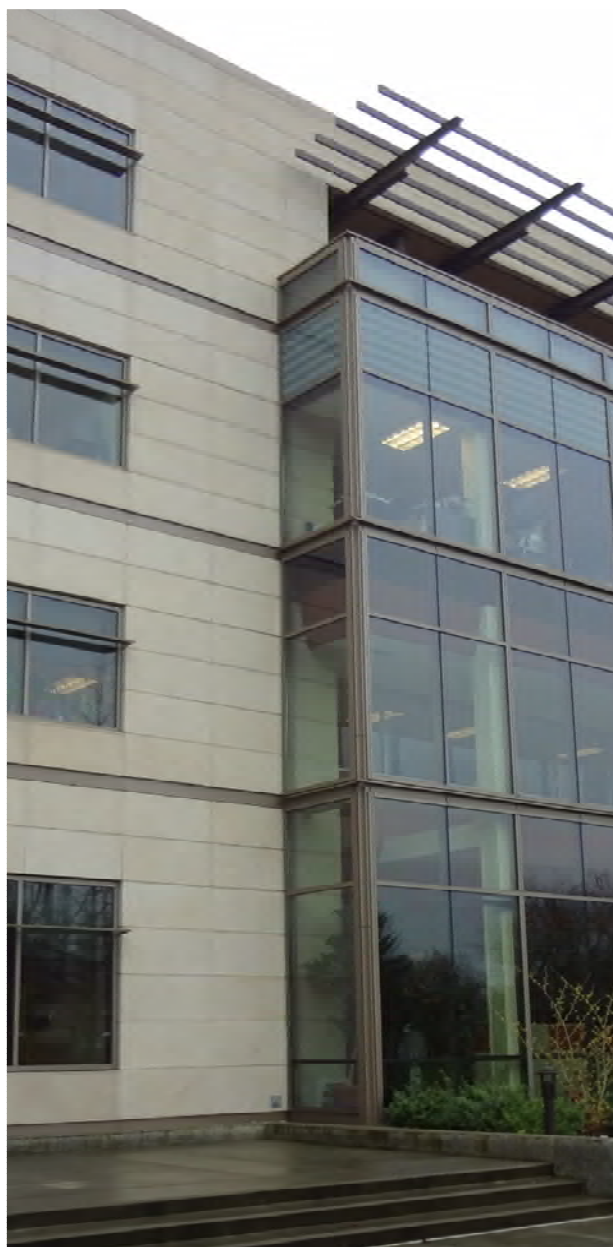
North side, East wall seam.

Thermal bridging along the seam of the building as the wall protrudes outward.

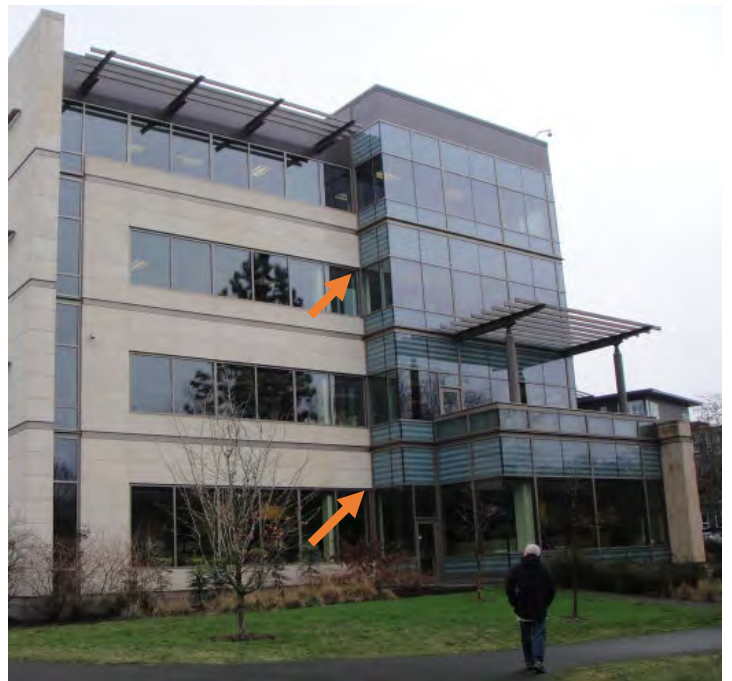
West side, North wing building exterior.

1<sup>st</sup> and 3<sup>rd</sup> floor heat loss around the window flashing at the intersection of the south wall and the glass exterior.

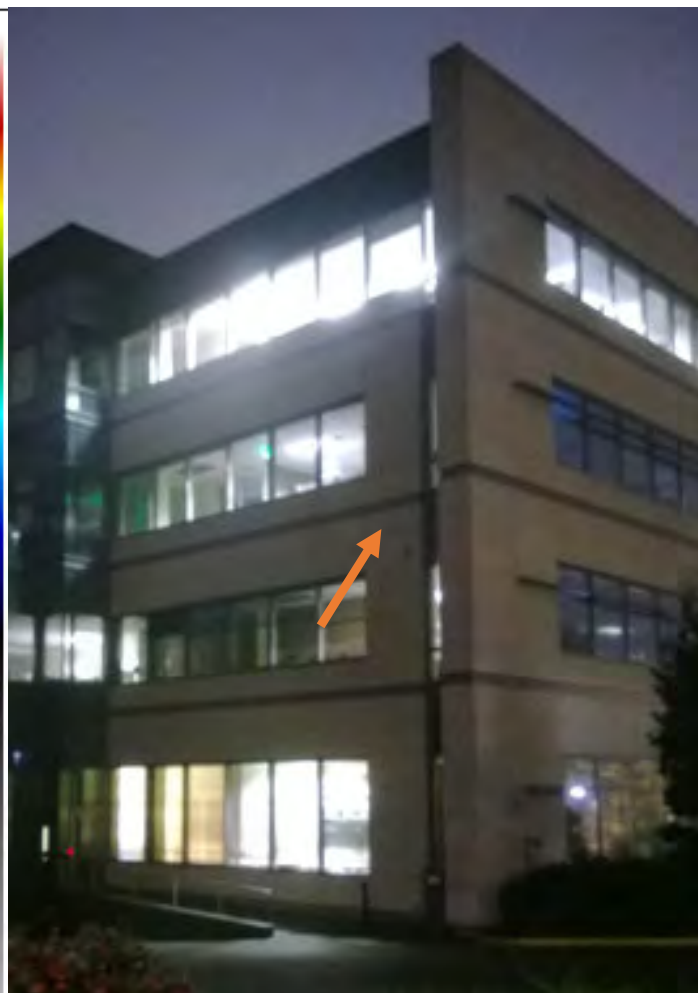
West side, southwest building exterior.

Thermal bridging at the intersection of the second and third floors and the wing wall.

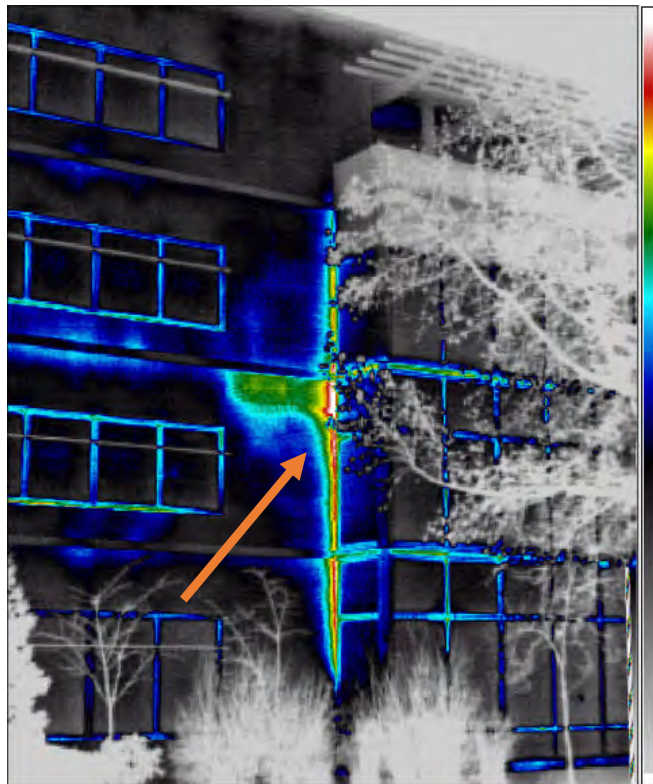
South side, West wall seam.

Thermal bridging at the intersection of the 2<sup>nd</sup> and 3<sup>rd</sup> floor where it meets the glass.

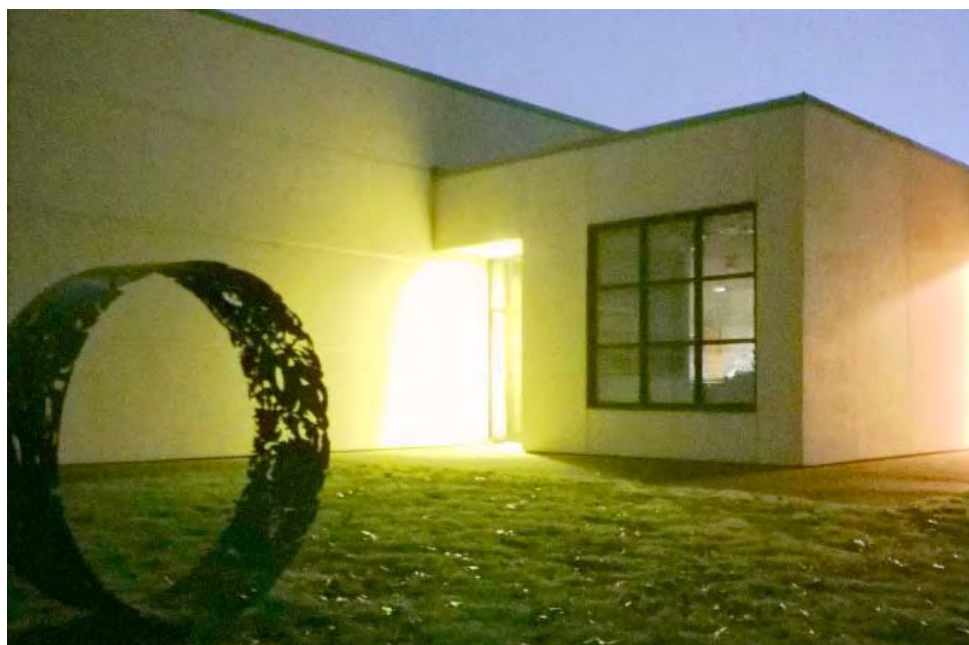
West wing, entrance exterior.

Area above entrance is showing thermal bridging in the entry way and around the door.
